CASE HISTORY

Ref: US0719

Permanent Repair Using X-PHALT™ of Asphalt Longitudinal Construction Joint

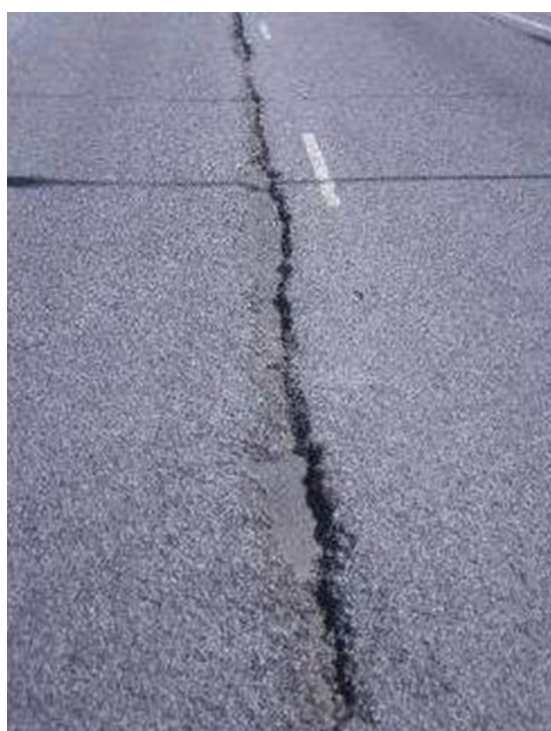
Problem: Longitudinal cracks are common between adjacent paved lanes. They are

caused by poor joint construction, pavement fatigue, reflective cracking, and / or an improper mix design. Water will enter the subgrade and can lead to deterioration of the substrate's soundness, particularly if the gap goes through all wear layers. The wearing surface failure will continue to expand under traffic conditions. Freeze – Thaw cycling during the winter months will significantly accelerate the roadway deterioration, resulting in potholes and hazardous gaps.

Figure 1: Longitudinal Construction Joint Crack between Lanes. Note the Large Gap Near the Foreground.

Traditional repair approaches: Gaps less than ½” wide are traditionally repaired with just a sealer. For larger areas the correct procedure is to remove the damaged material and replace it with an overlay using hot mix asphalt. However, this method requires onsite heavy equipment and is expensive. Cold patch repairs, which are temporary, are too often used instead due to their ease and reduced cost. However, cold patch has a service life expectancy of 6 to 12 months before failing due to ejection, rutting, shoving, etc.

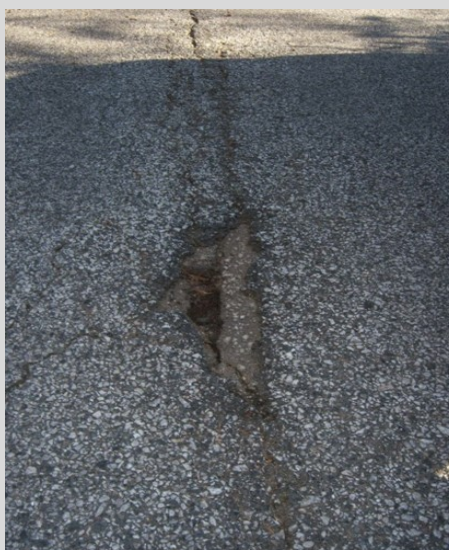
Figure 2: Full Depth Construction Joint Longitudinal Crack

- X-PHALT cementitious repair mortar will chemically bond to the bitumen in asphalt pavement, creating a permanent repair.
- X-PHALT is applied in the same way as with concrete repair mortars – add water; mix using a drill & paddle, drum, or mortar mixer; and place.
- X-PHALT forms a hardened cement that will not rut, shove, or eject.
- X-PHALT cleans up with water; does not burn skin like Portland cement; does not require a bonding layer, heat source, or heavy onsite equipment; and does not contain any solvents or VOC's, nor any noxious odors.

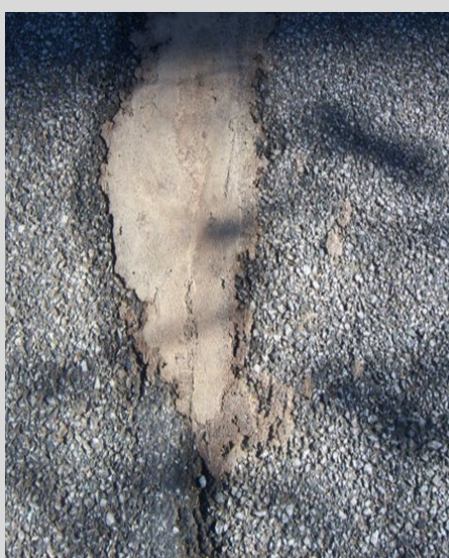
Figure 3: Repair made with X-Phalt™ after 1 year of heavy trafficking

The result is a repair that will last as long as the surrounding road surface.
